## Memorandum

RE Golden Gate Theater, 909 S. Atlantic Boulevard, Los Angeles CA  
*Secretary's Standards* Conformance Review (Revised Version)

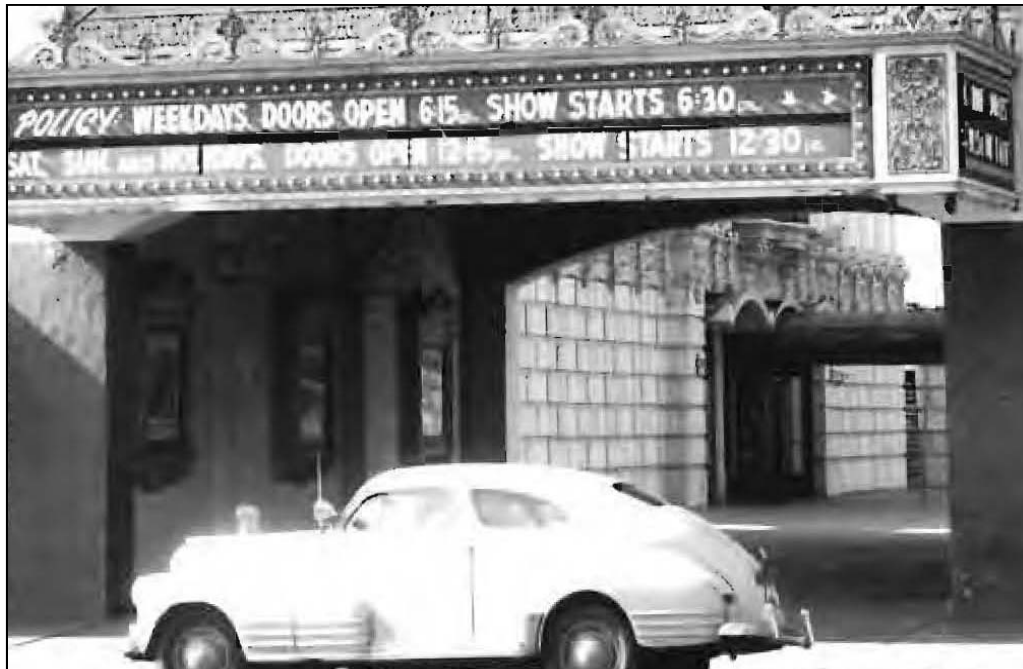
- Canopy remnant over main entrance shall be restored. While a contemporary canopy was proposed in the *modified project design*, recent research has yielded images of the canopy's original appearance, making possible its accurate restoration (Appendix A, figs 10 and 13).

Figure 10: Golden Gate Theater and Vega Building (demolished), detail view southwest showing entrance to theater through Vega Building, 1955 (Academy of Motion Picture Arts and Sciences Library, B'hend and Kaufmann Collection)

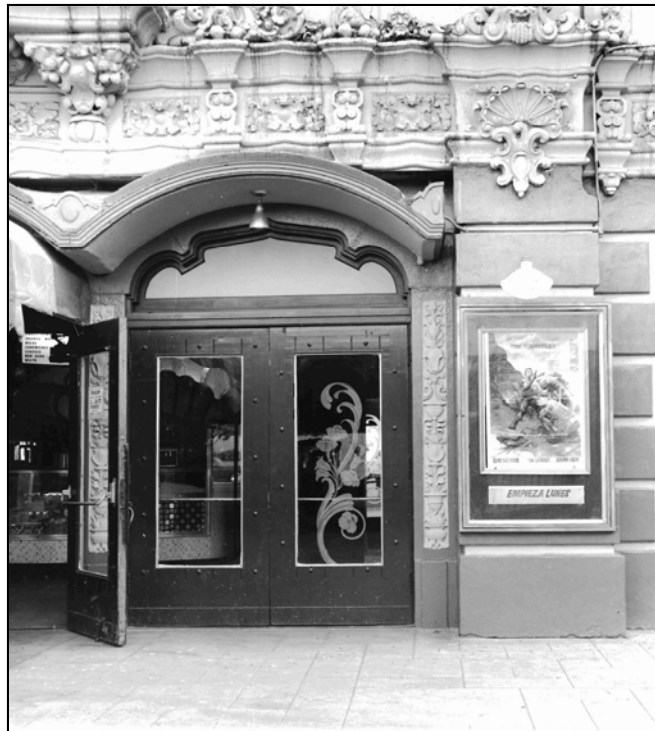
Figure 13: Golden Gate Theater, detail view south of main entrance, c. 1980s (Tom Zimmerman)

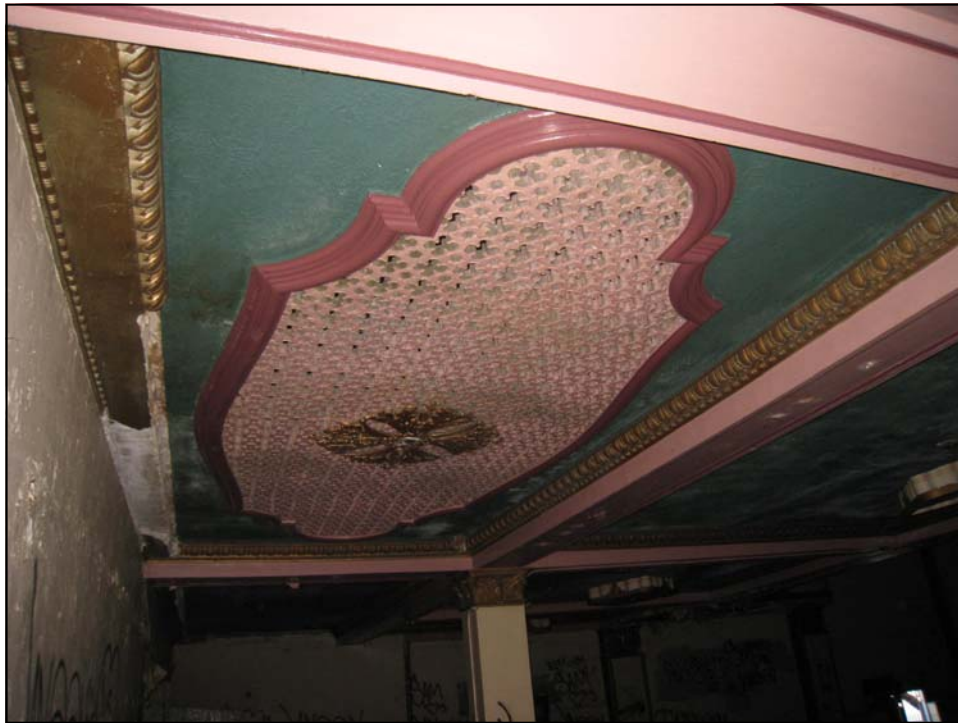
Figure 41: Golden Gate Theater, interior, view east of underside of balcony (Chattel Architecture 2009)

- As per the project Conditions of Approval (Appendix D), historic ceiling-mounted fixtures at balcony underside will be restored and remounted to be visible from sales floor; they will be made functional if possible (sheet HPD-3.1, note 17 and sheet A-3.1). Two historic chandeliers originally located above balcony will be restored and remounted to be visible from the sales floor in locations of existing junction boxes located near gridline B.7 (sheet HPD-3.1.1 and sheet A-3.1.1). Extant remnants of historic fixtures and chandeliers not reused, along with remnants of any extant historic wall sconces shall be carefully recorded, salvaged, crated and stored on site in the balcony mezzanine.

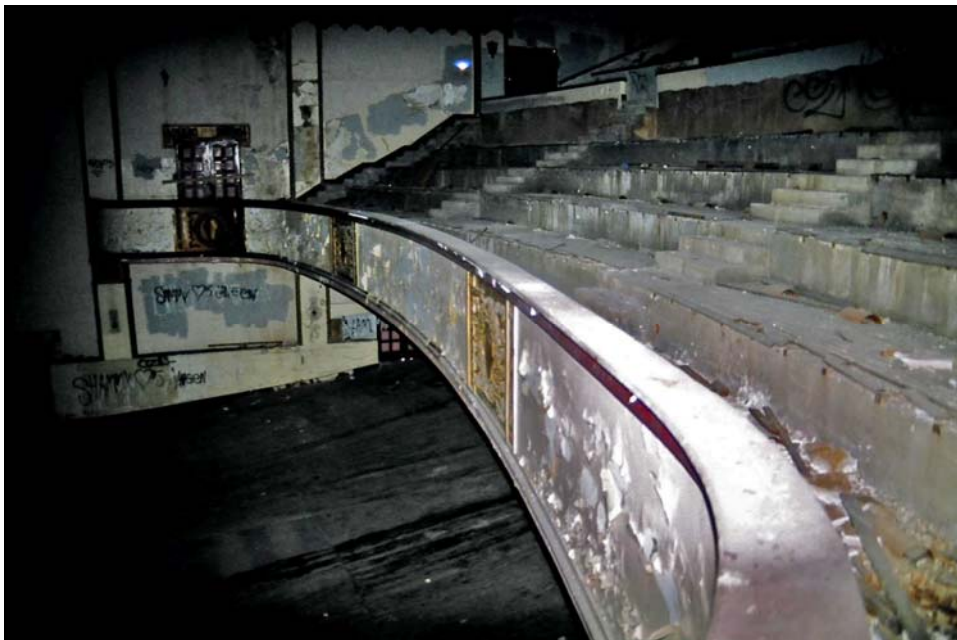
Figure 44 Golden Gate Theater, interior, view northwest showing balcony seating and balcony edge (Chattel Architecture 2009)

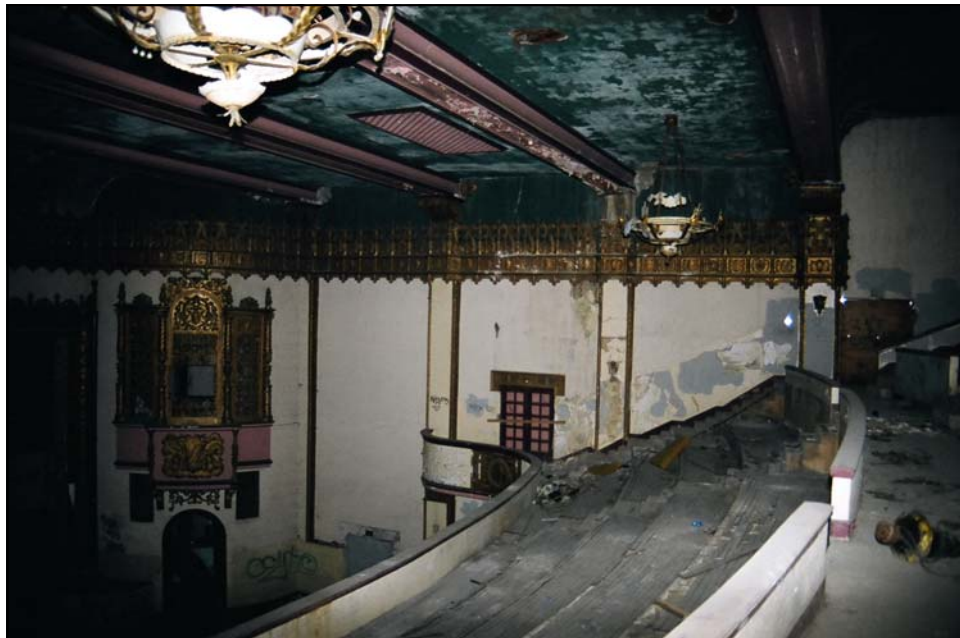
Figure 45: Golden Gate Theater, interior, view southwest from balcony showing balcony seating (right) and edge of proscenium arch (left) (Chattel Architecture 2009)

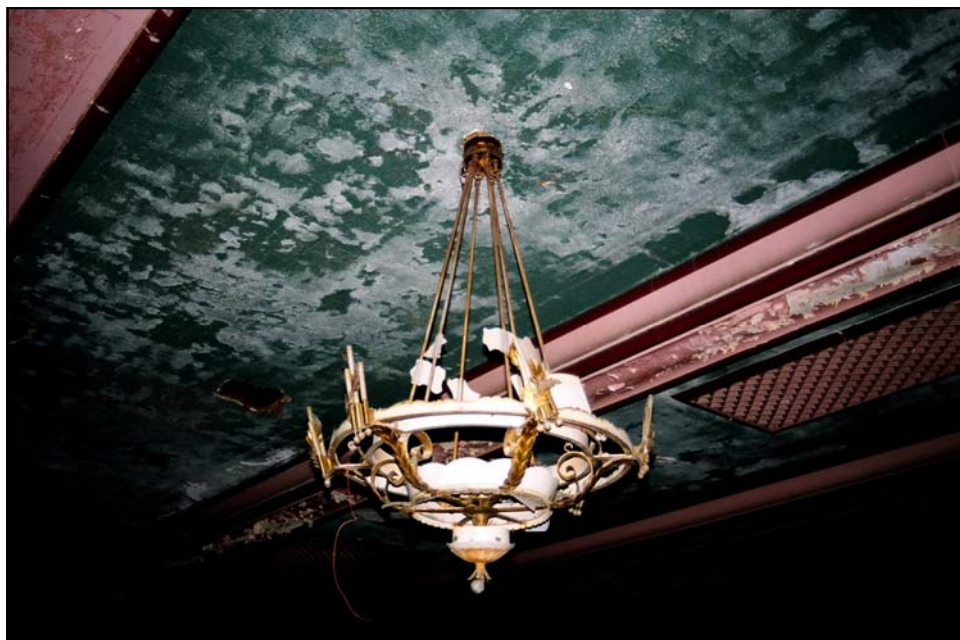
Figure 46: Golden Gate Theater, interior, detail view of ceiling light fixture above balcony (typical) (Chattel Architecture 2009)

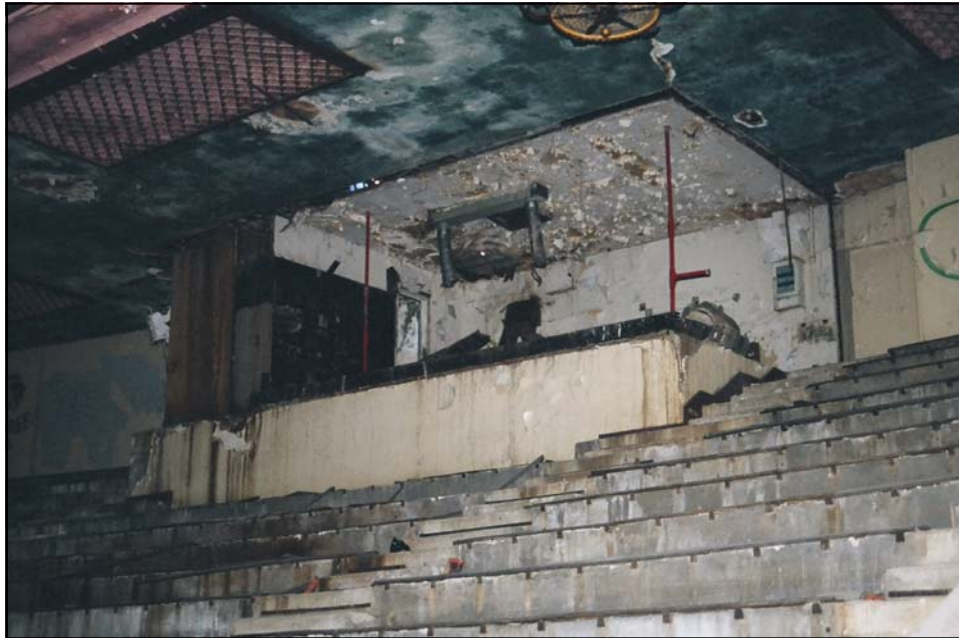
Figure 47: Golden Gate Theater, interior, view northwest from balcony seating looking toward projection booth (Chattel Architecture 2009)

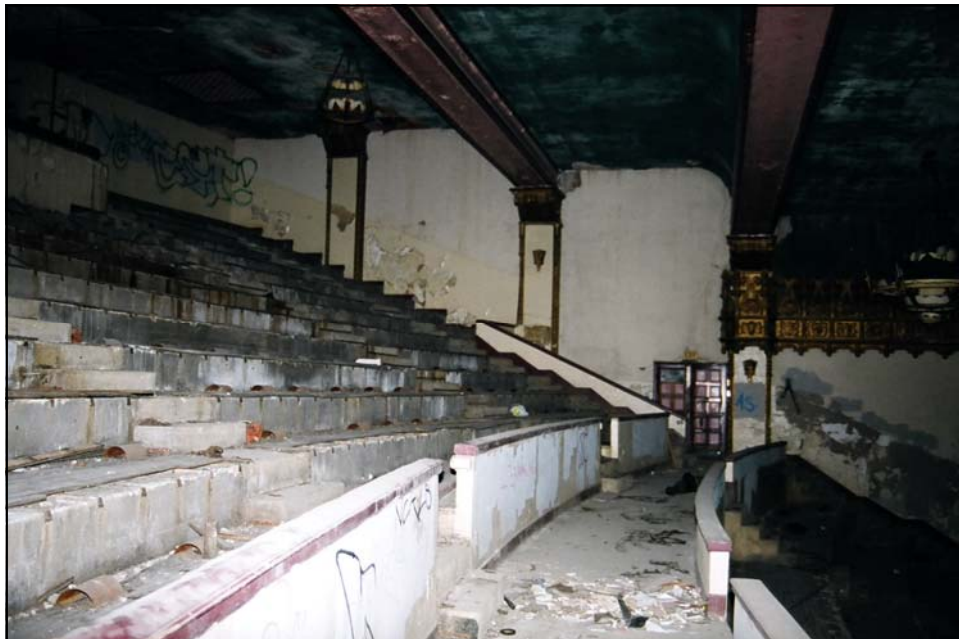
Figure 48: Golden Gate Theater, interior, view northeast from balcony (Chattel Architecture 2009)

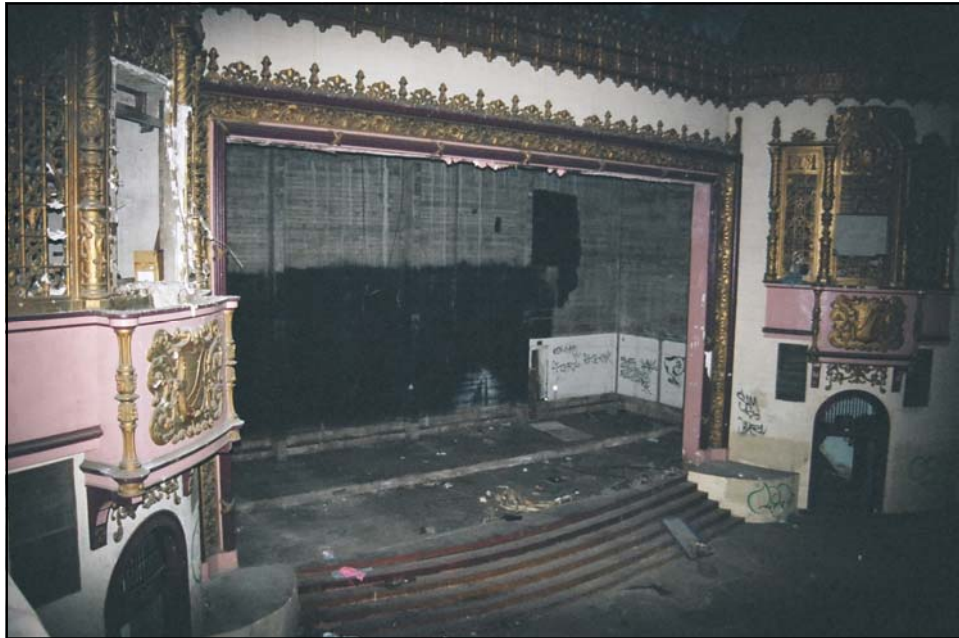
Figure 49: Golden Gate Theater, interior, view southwest looking toward stage  
(Chattel Architecture 2009)

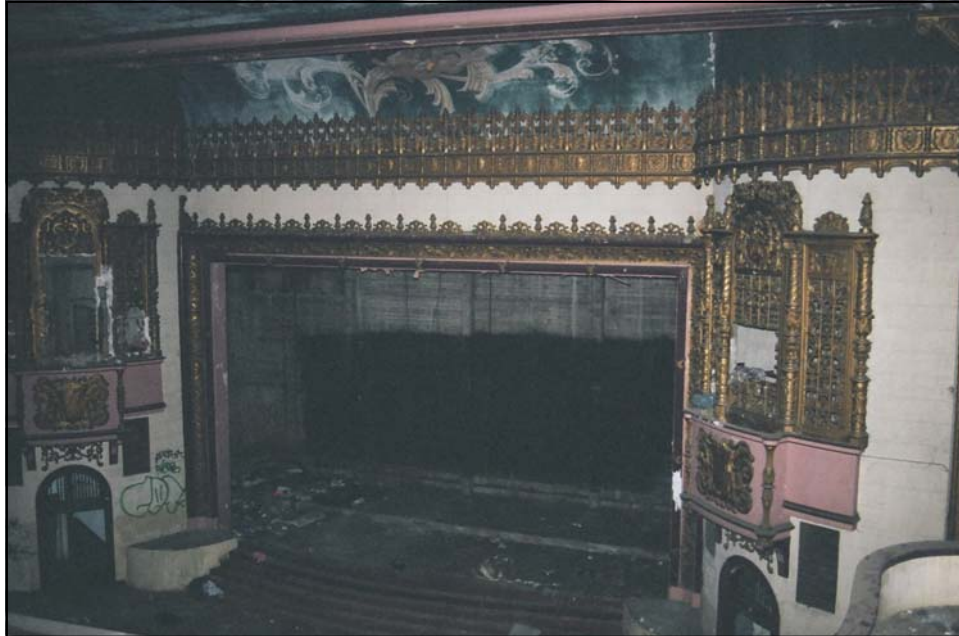
Figure 50: Golden Gate Theater, interior, view southeast looking toward stage  
(Chattel Architecture 2009)

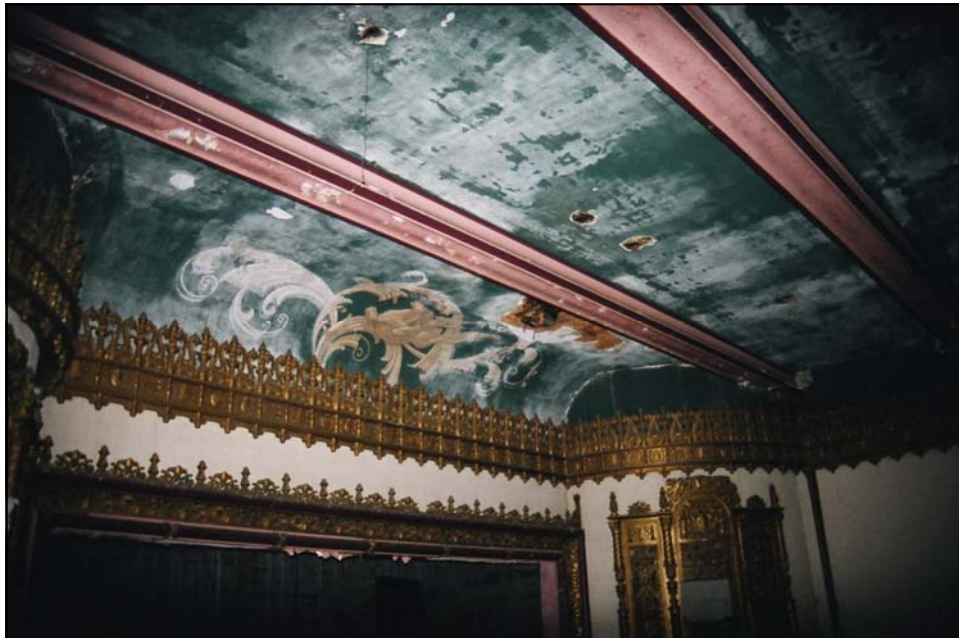
Figure 51: Golden Gate Theater, interior, detail view southwest showing proscenium arch and ceiling detail (Chattel Architecture 2009)

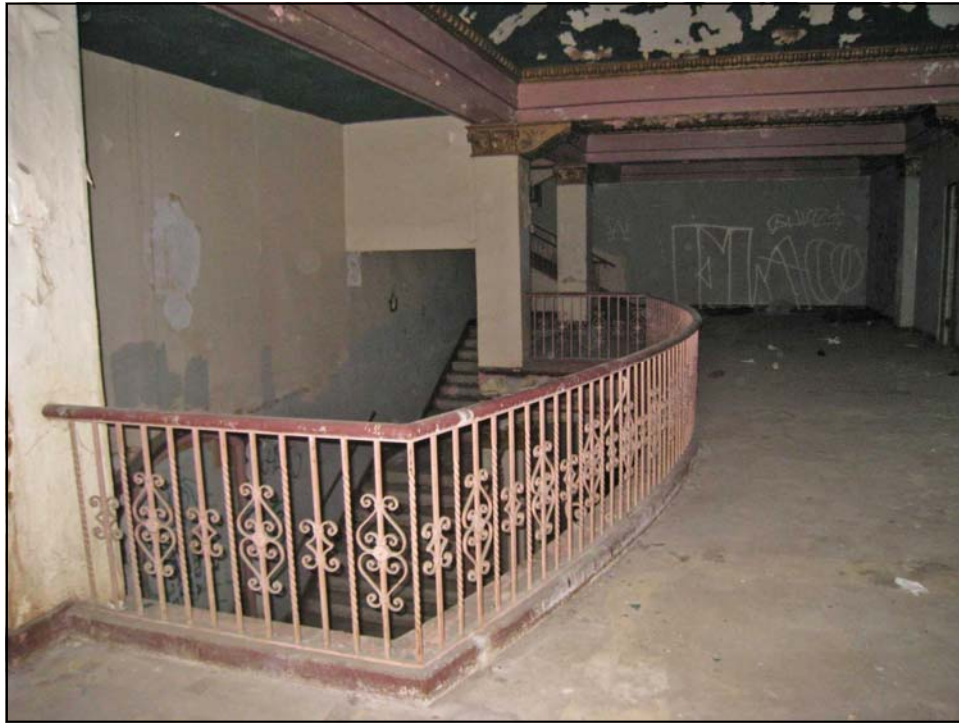
Figure 55: Golden Gate Theater, interior, view southwest of mezzanine lobby (Chattel Architecture 2009)

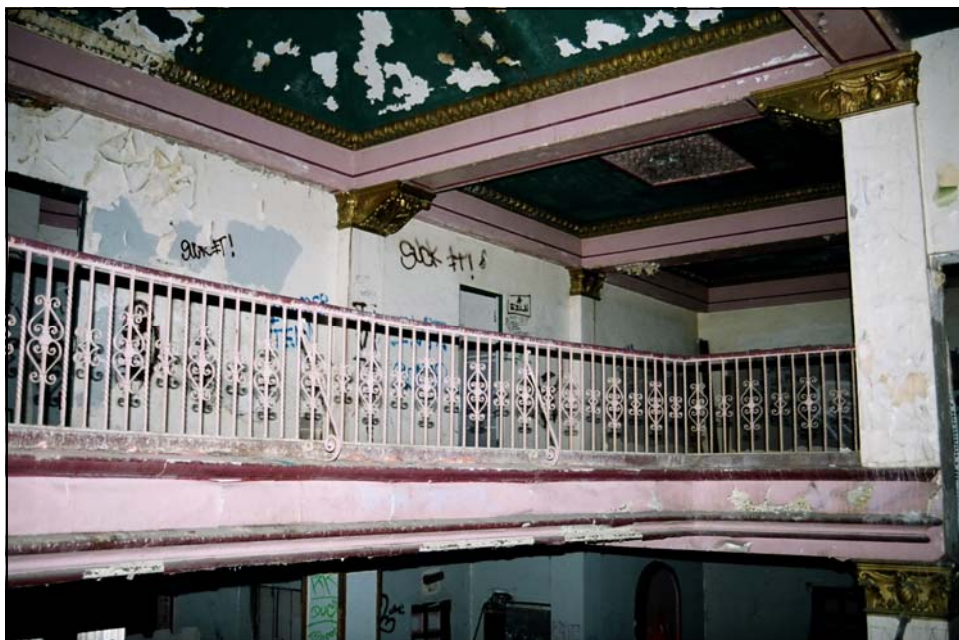
Figure 56: Golden Gate Theater, interior, view northeast of mezzanine lobby (top) and ground floor lobby (bottom) (Chattel Architecture 2009)
